Case studies – slip ring machines

Schunk Kohlenstofftechnik

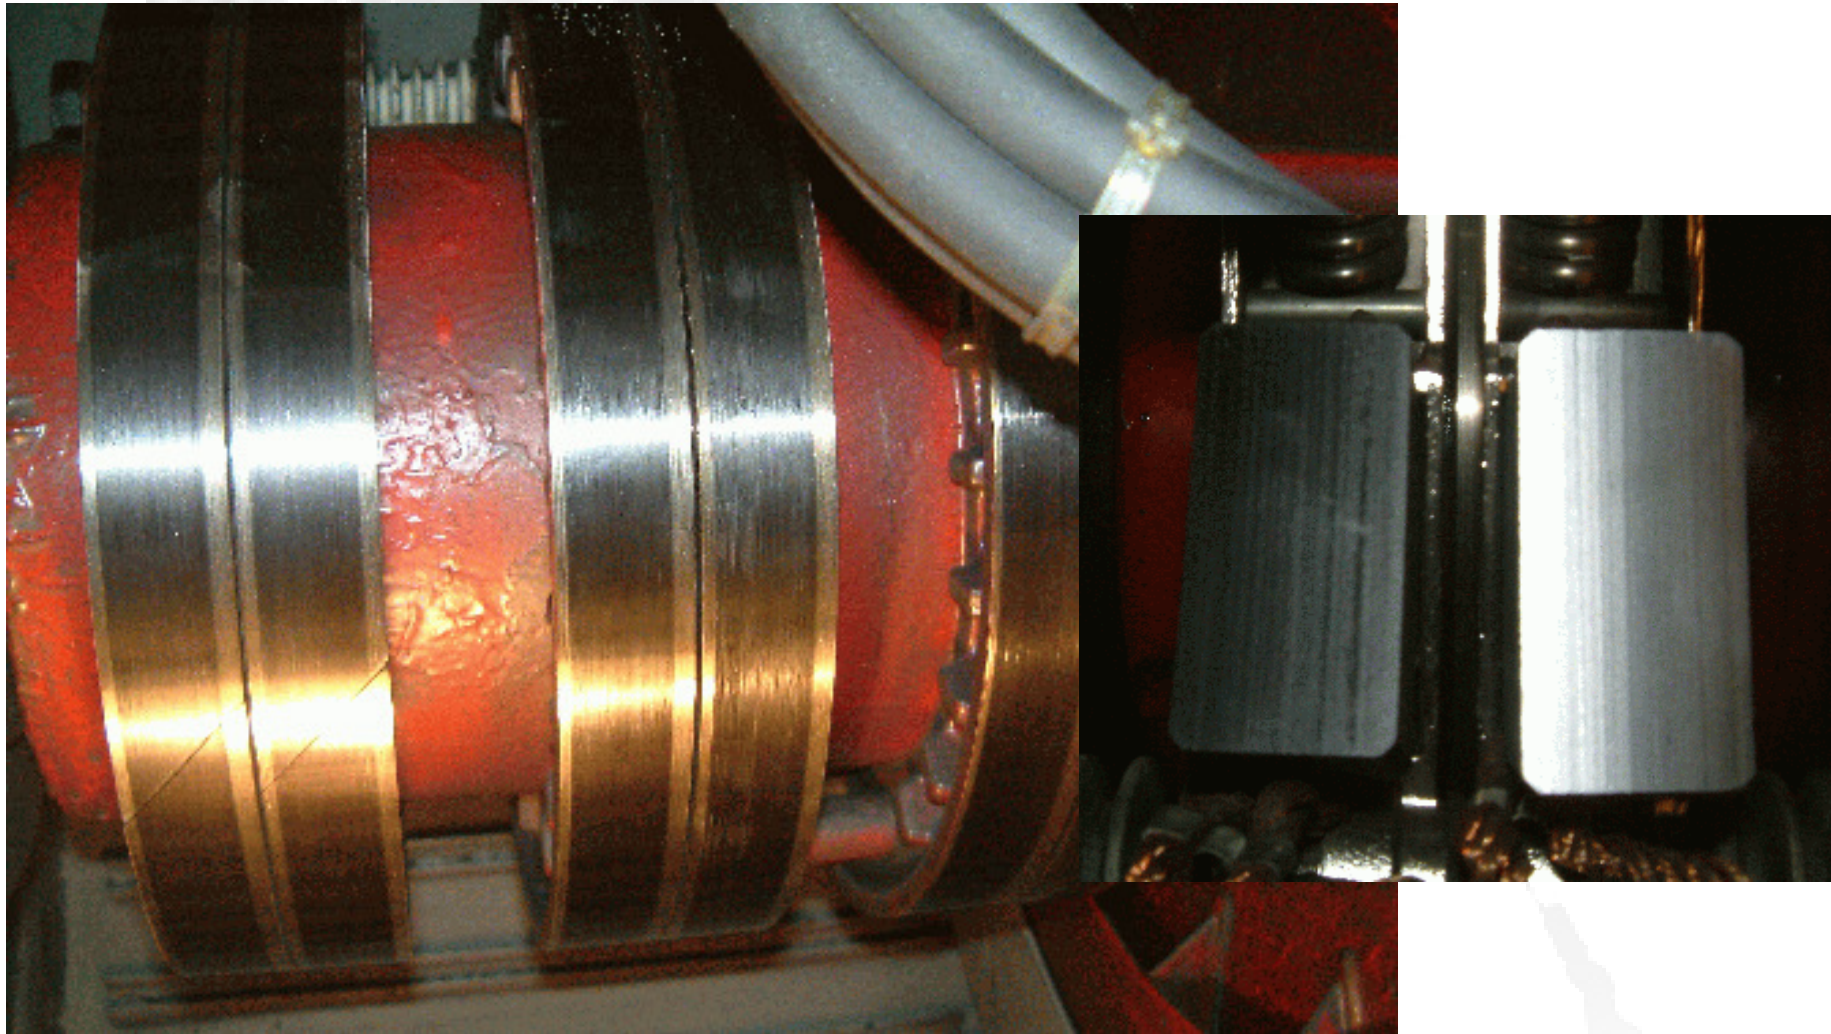
Good performance

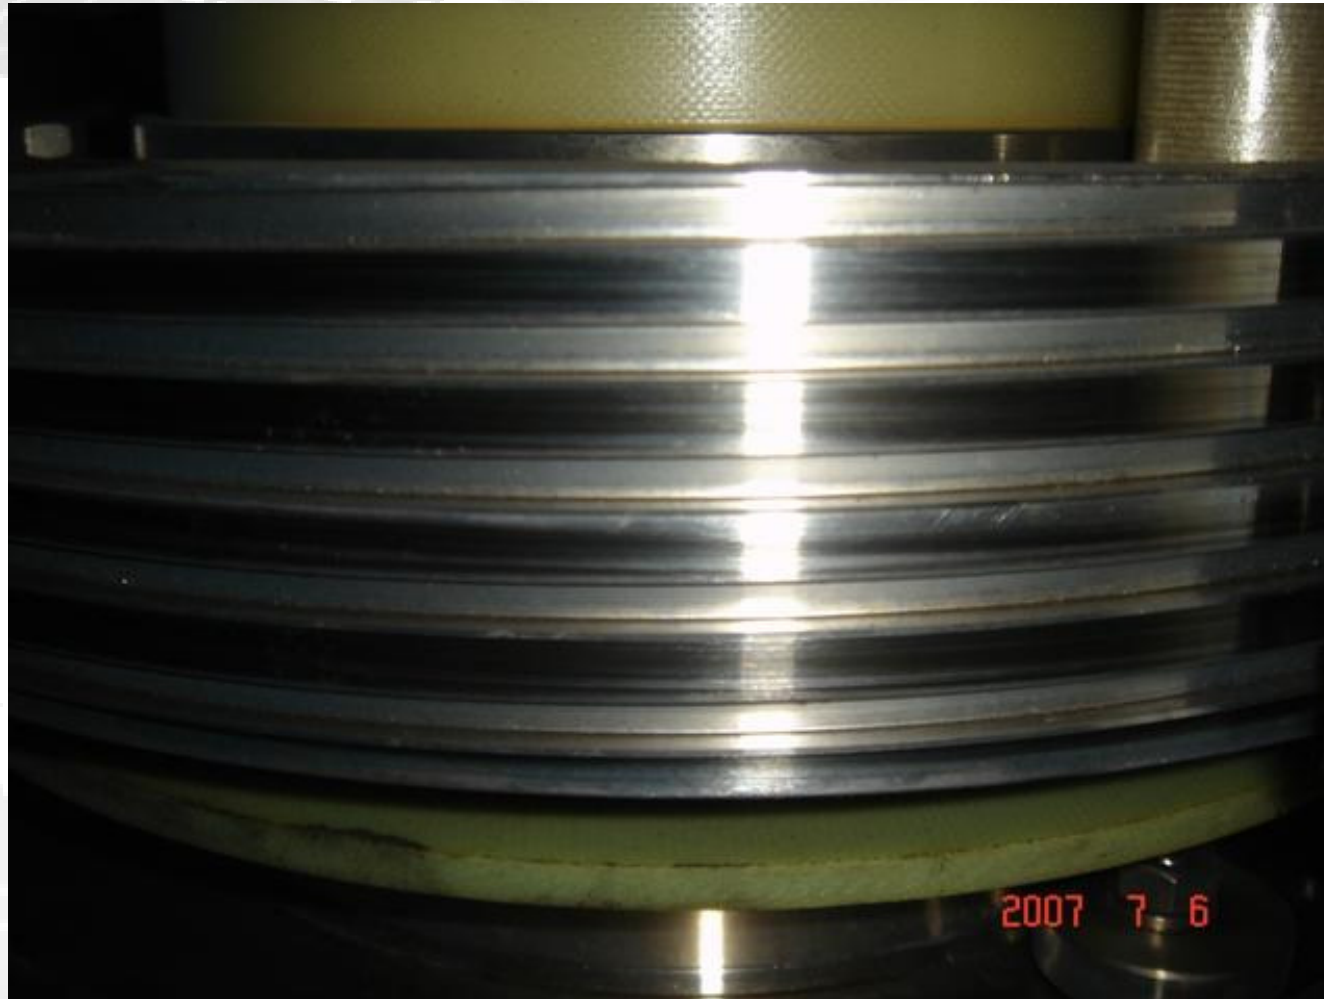
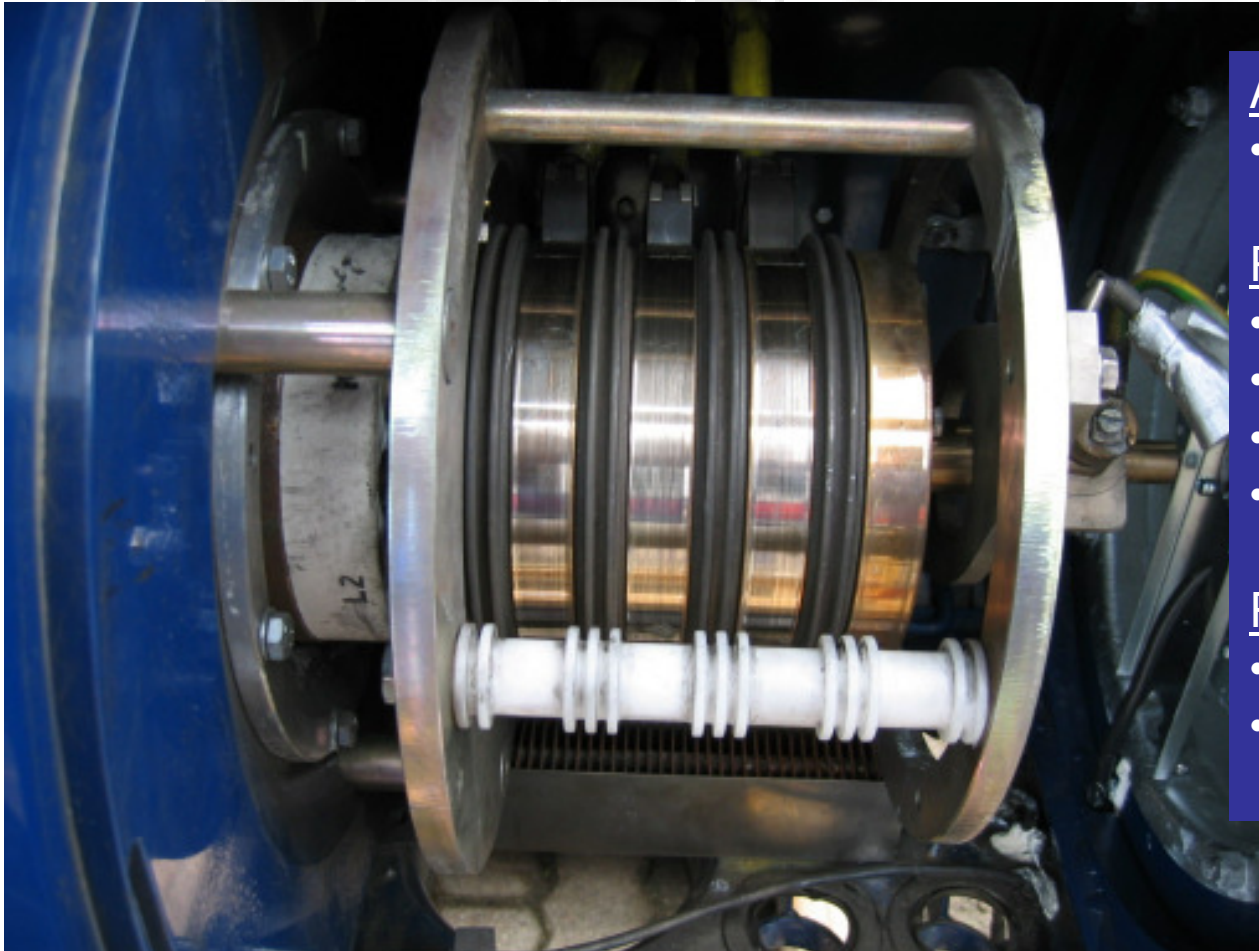
Too smooth surface

- smooth, shiny surface

- No film formation
- High friction of carbon brushes
- Brush vibrations
- Ring wear-out

- Grinding of ring surface
- optimal surface roughness
Rz 5-8 μ m (Ra 0.8-1.2 μ m)

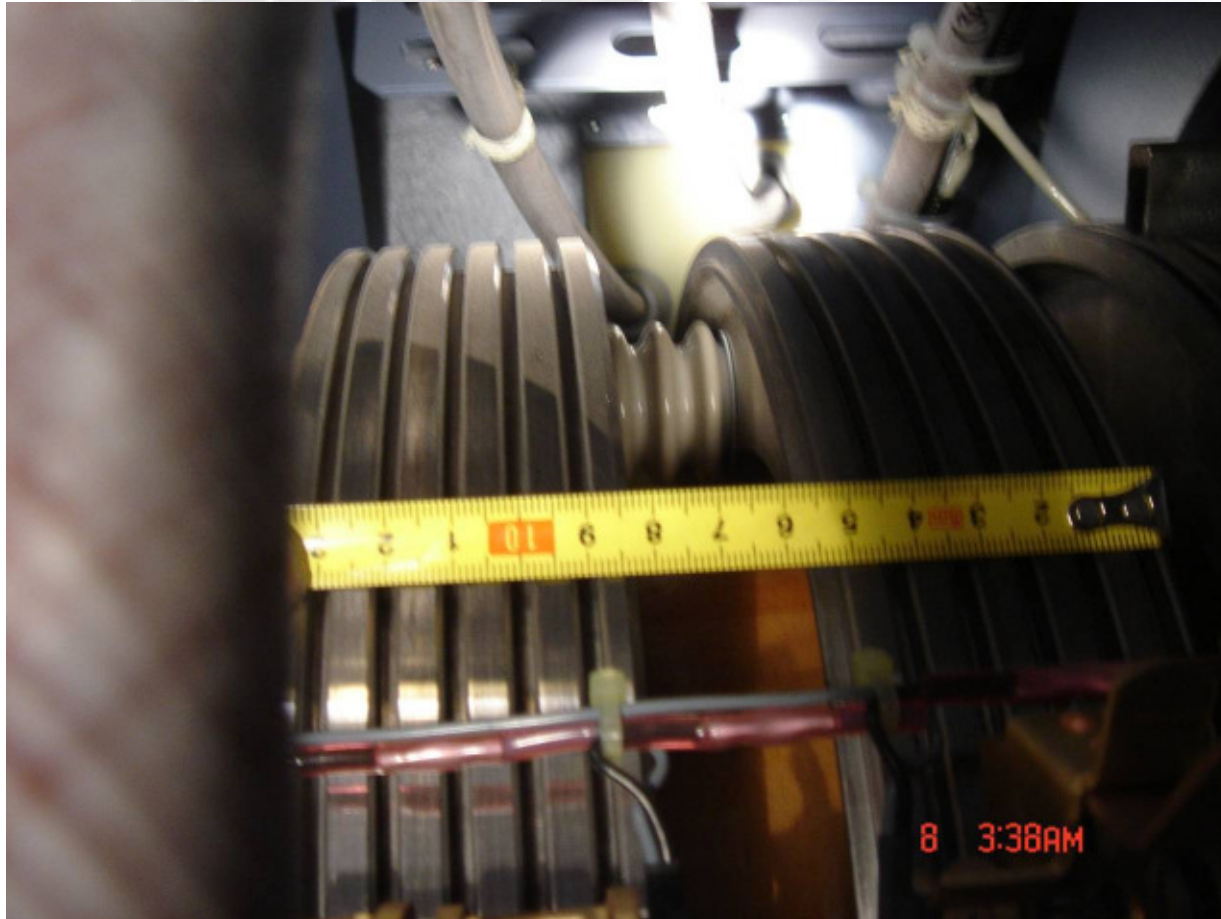
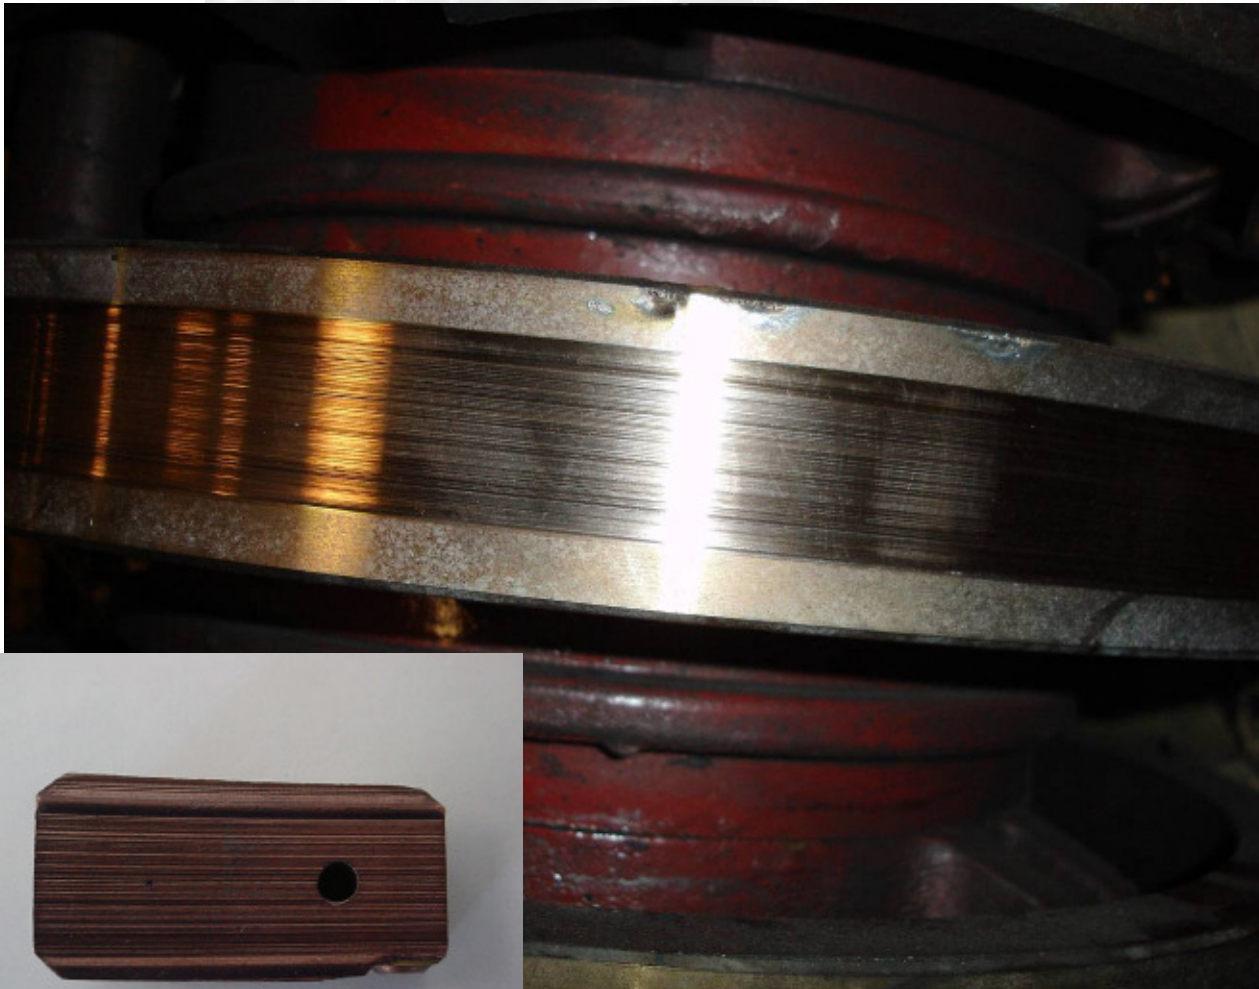
Too smooth surface

- Palpable grooves in the brush contact surface and on the ring surface
- film disappeared

- abrasive dust and / or
- too low ring temperature
- too low electrical load

- Check ring temperature (opt. 60-90 °C)
- Check load condition
- Filtering

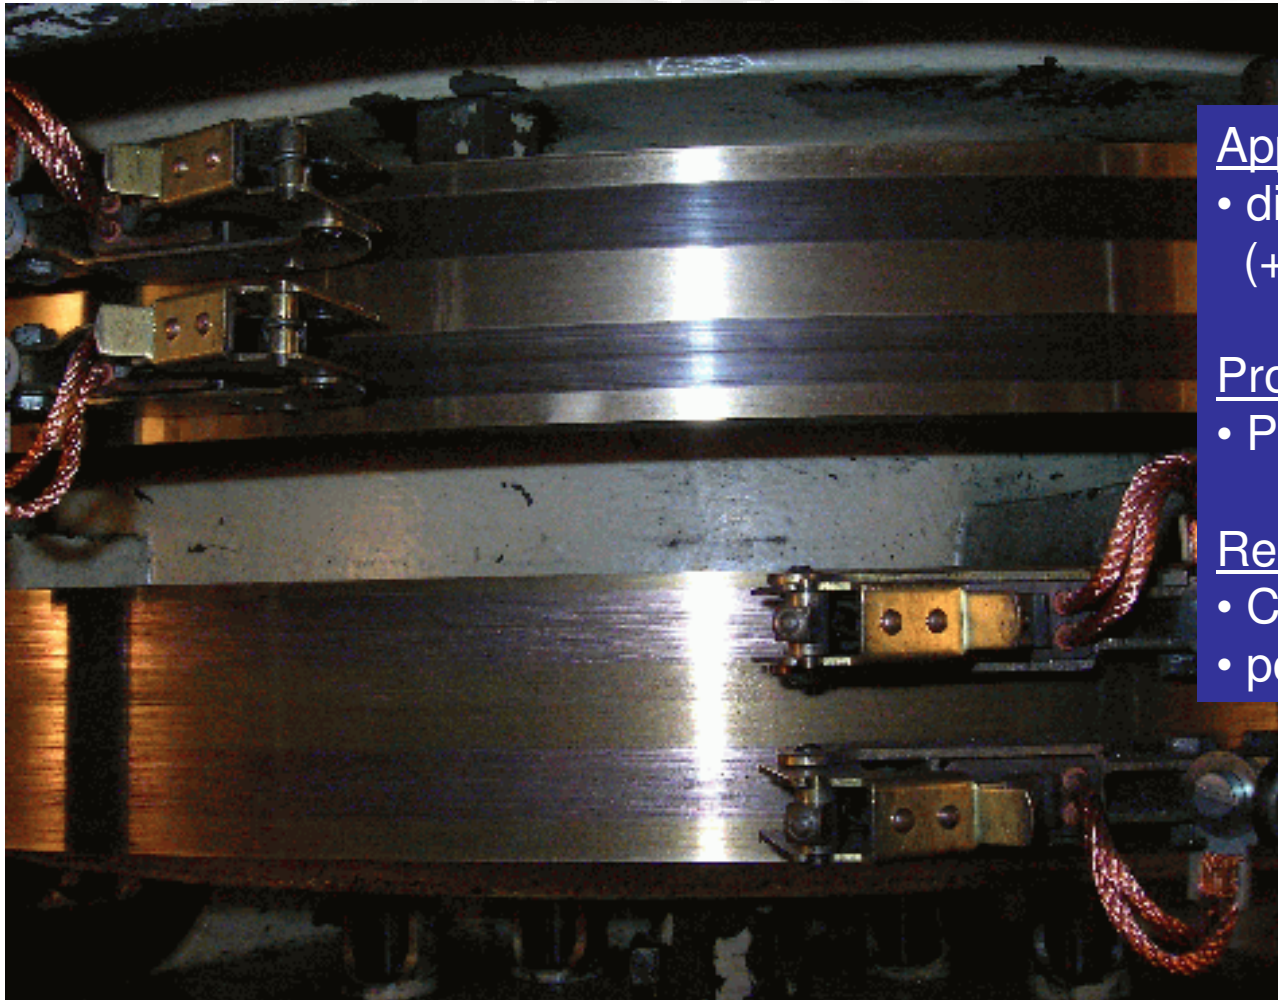
Different film formation

- different film formation on (+) and (-) ring

- Polarity effect

- Change of polarity
- possibly different brush grades

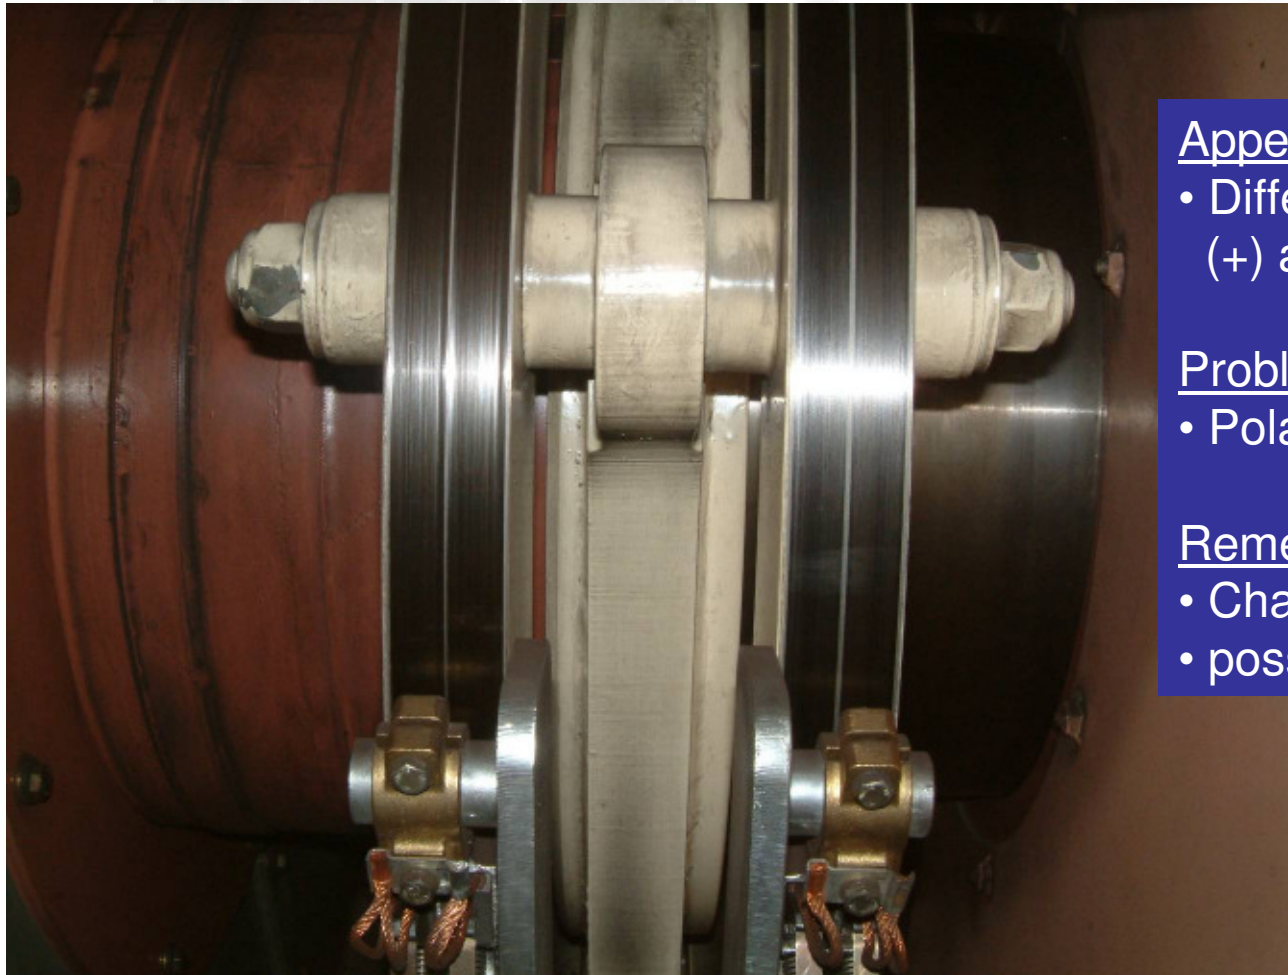
Ring attack by means of polarity effect

- Different ring wear-out on (+) and (-) Ring

- Polarity effect

- Change of polarity
- possibly different brush grades

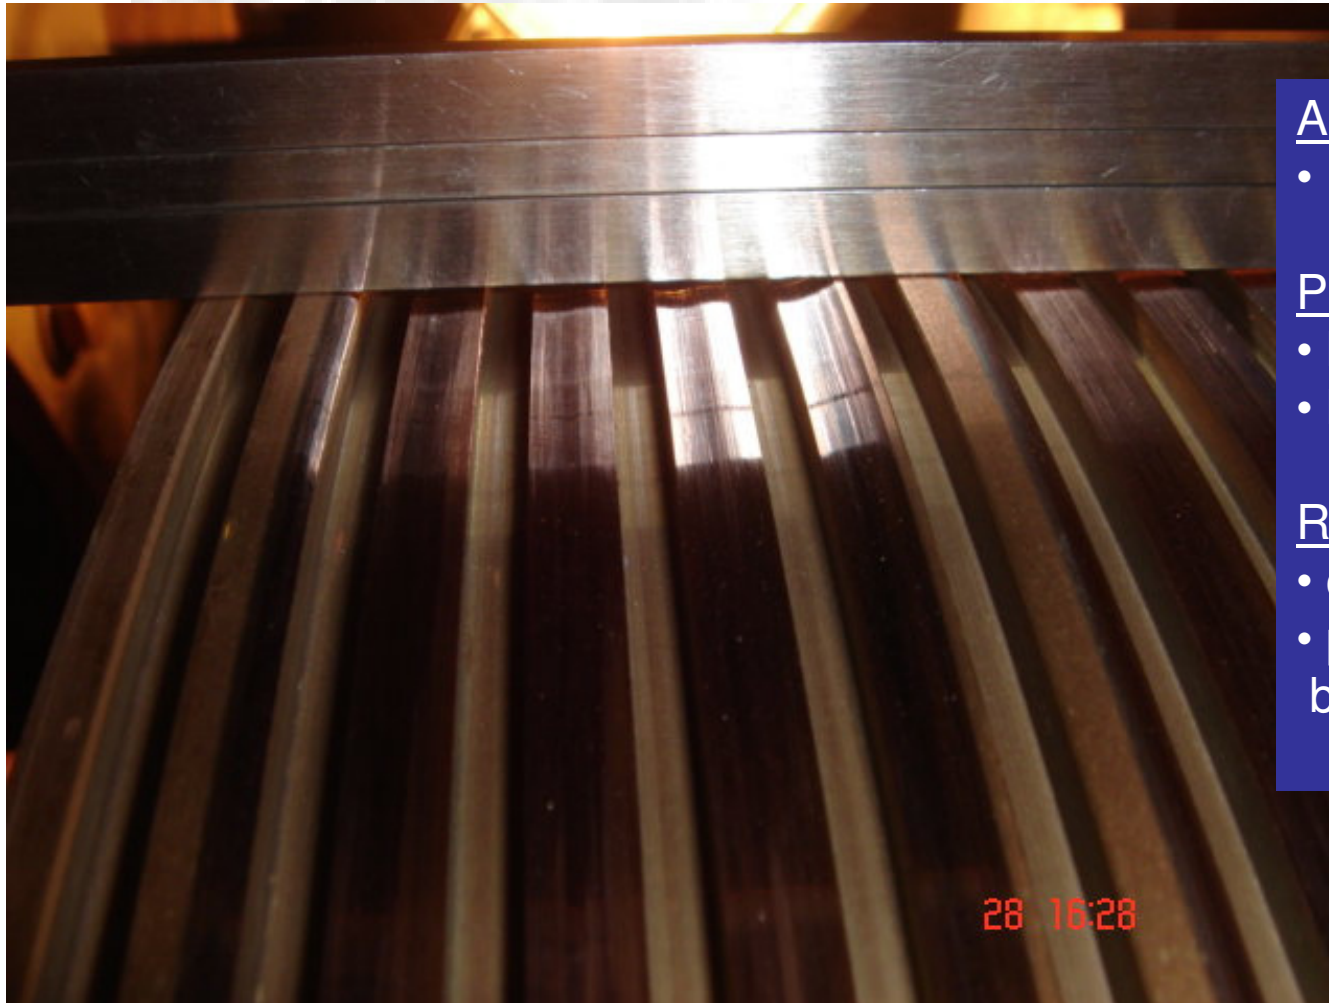
Ring attack

- Ring wear-out on all rings

- low load
- low temperature ($< 40^{\circ}\text{C}$)

- check current density
- possibly reduce number of brushes

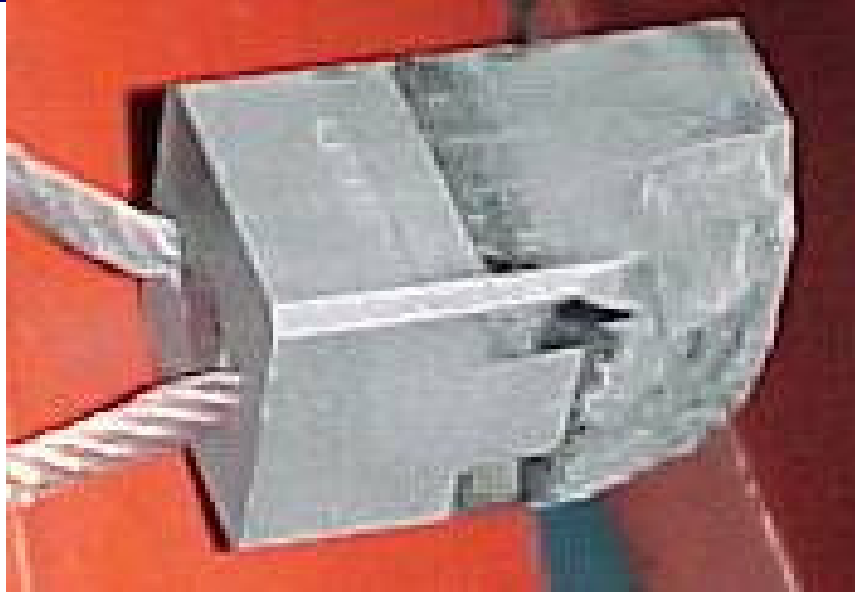
- Damage of brush edges
- Broken brushes

- high friction by means of smooth ring surface and / or high temperature

- Check of surface roughness
- Roughening of the surface
- Change of cooling

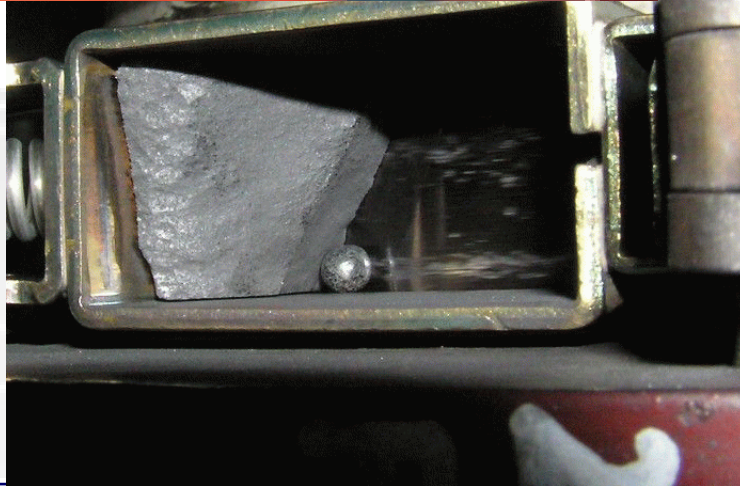
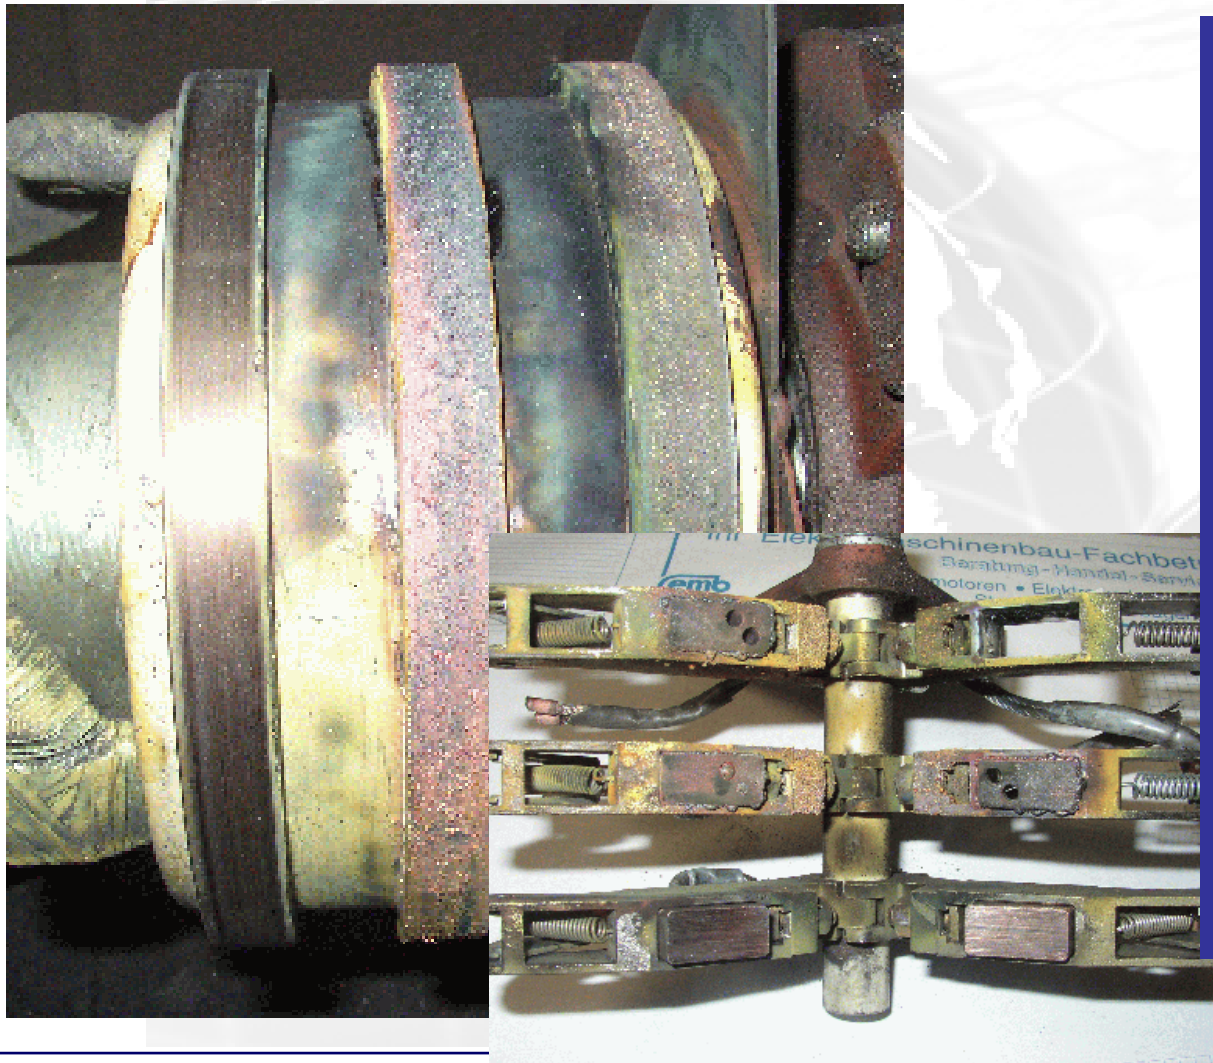
- Destroyed brush holders and rings

- Flash over by means of
 - Vibration
 - Voltage peak
 - dirt

- Regular cleaning
- Check of out-of-roundness
- Check of basement
- Sufficient ventilation for removal of brush dust

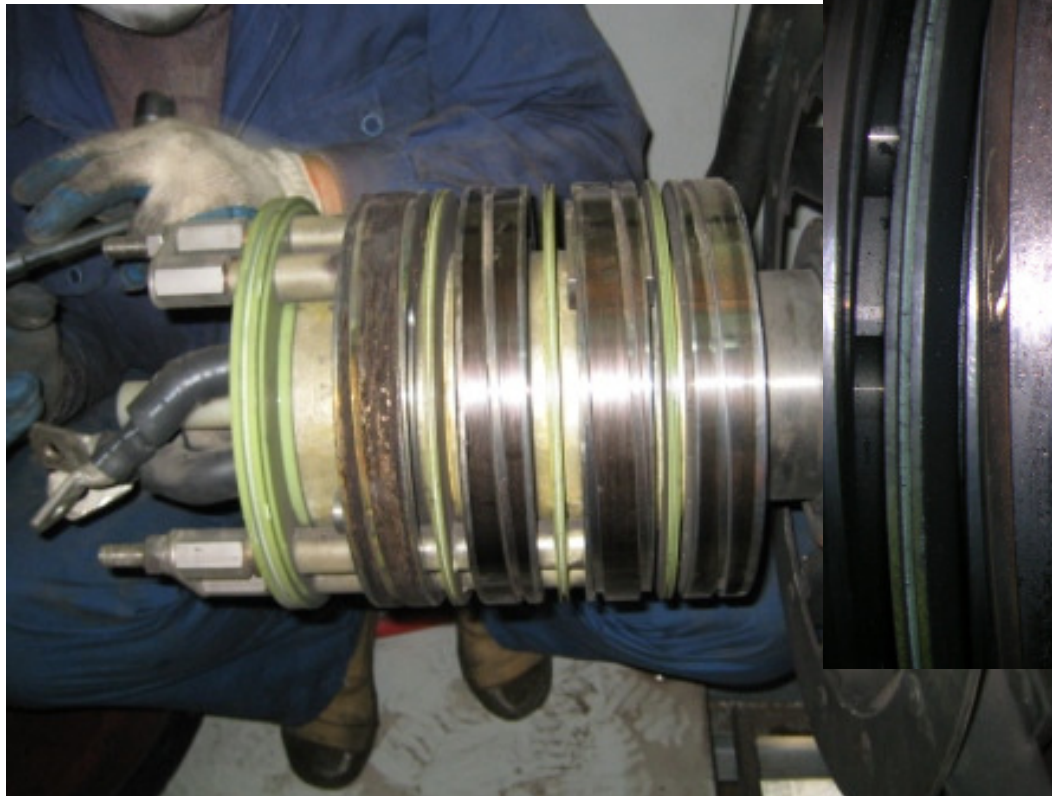
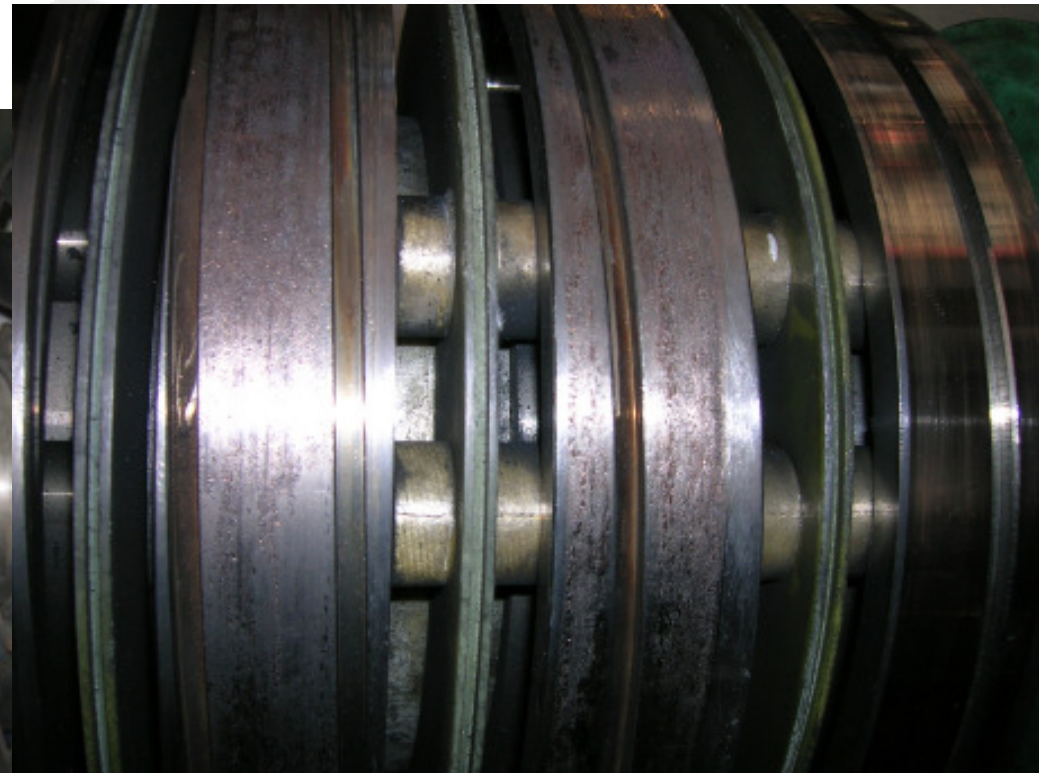
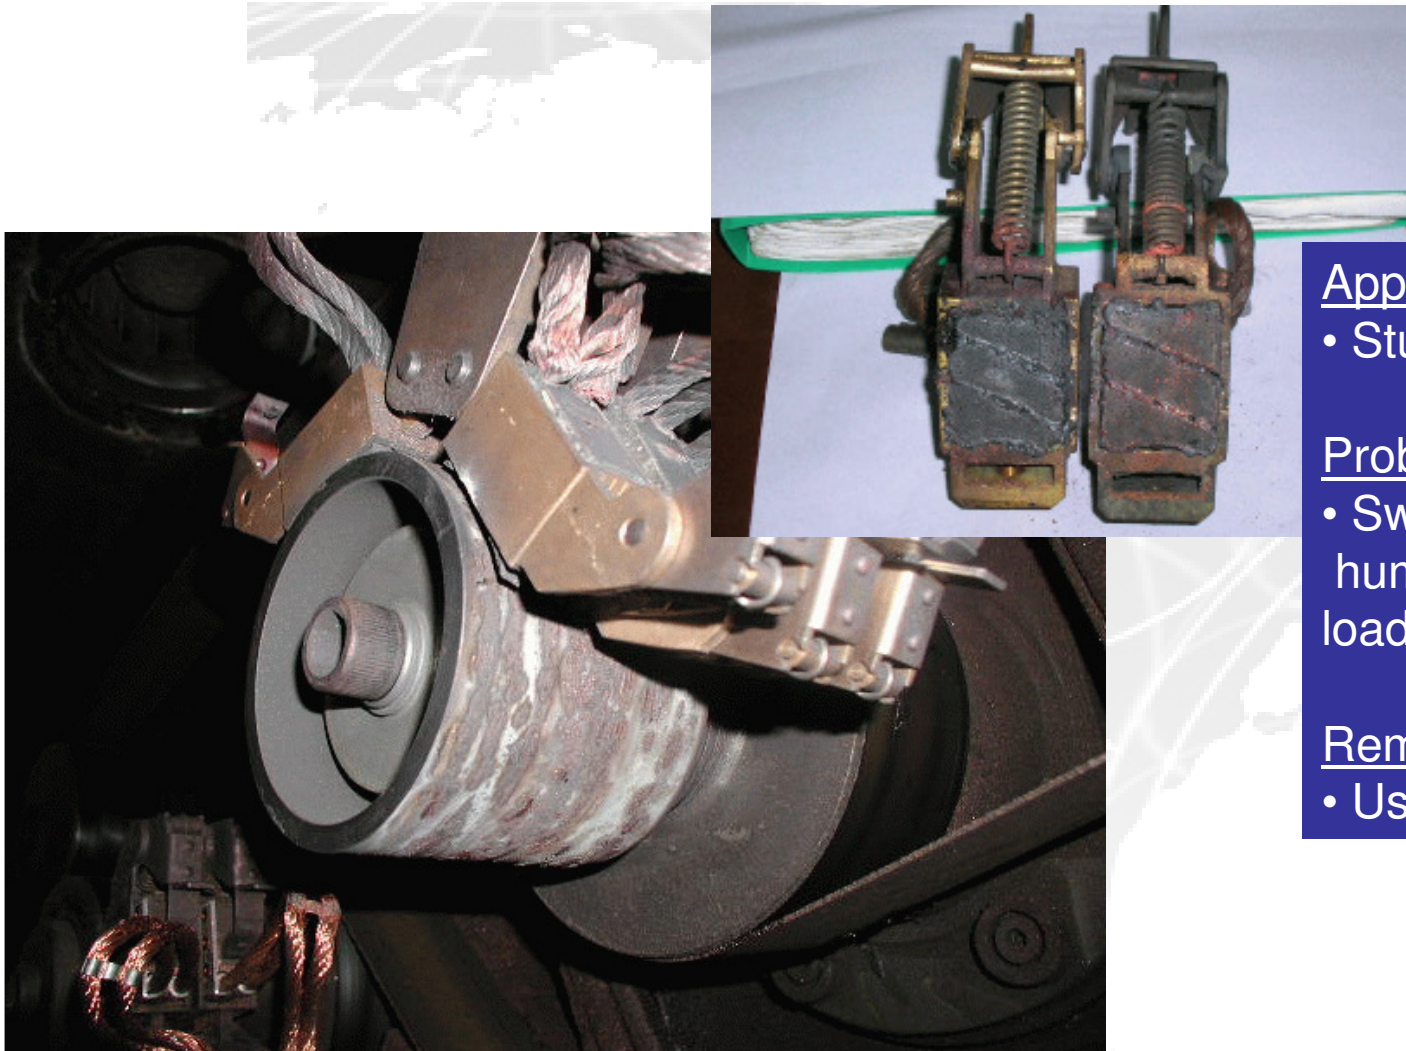
Flash over

- Stuck brushes

- Swelling of the brush at high humidity and high electrical load

- Use optimised brush grades

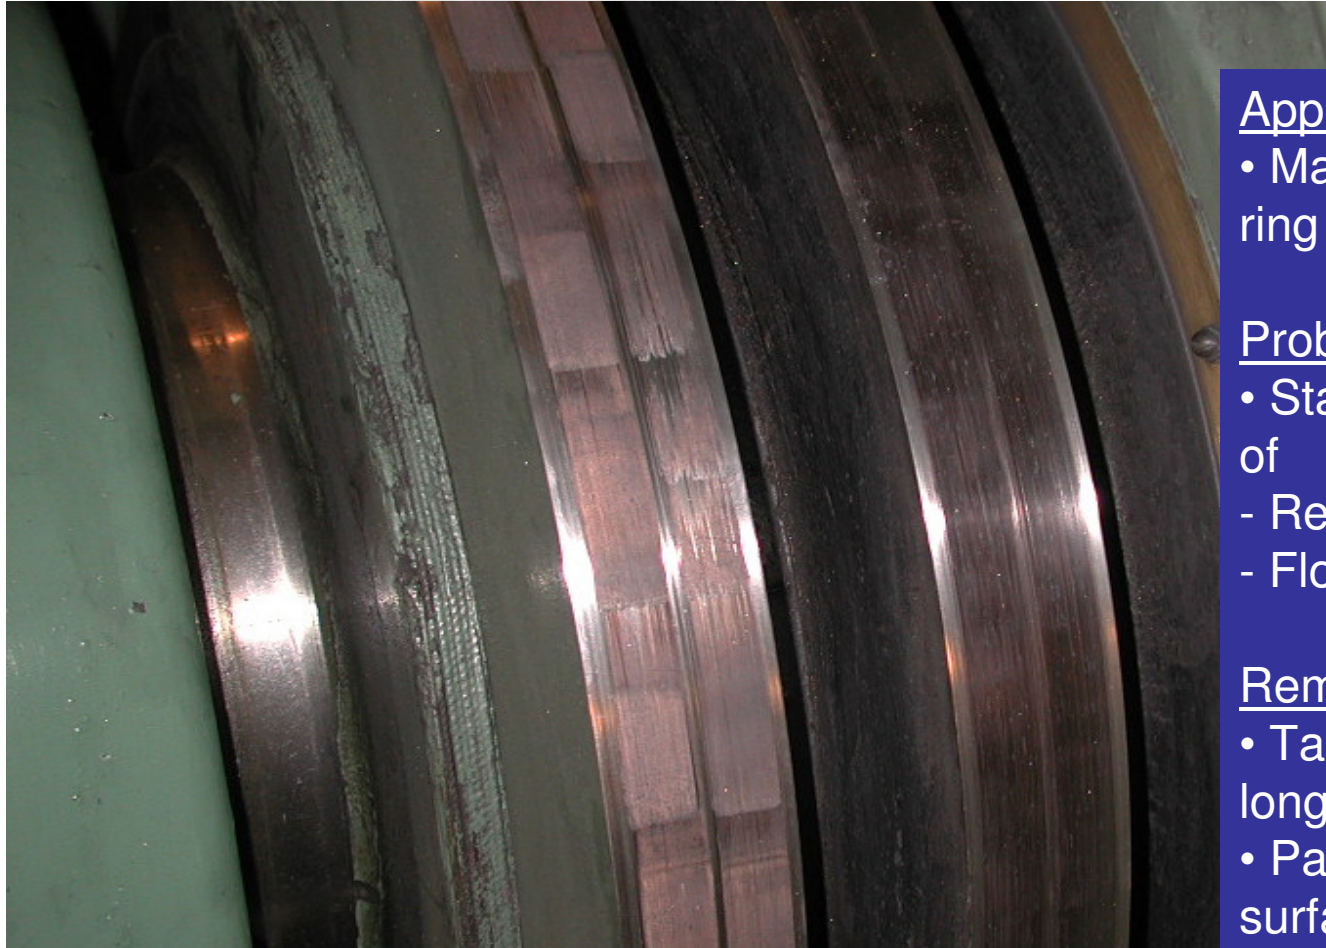
- Markings in brush size on the ring surface

- Stand still corrosion by means of
 - Residual current
 - Flow of ions

- Take off the brushes in case of long stand still periods
- Paper underneath the contact surface
