Technical information

Dr. Ulrich Ringleb

18.08.08

Burn Marks on Commutator Surfaces

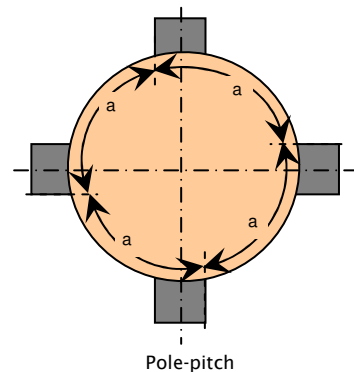
Often “commutator blurs in pole-pitch” can be observed, in an advanced state also “out-of-roundness in pole-pitch”. Pole pitch is the distance between the brush arms.

Here one bar is more burned than the adjacent one – accidentally or by means of electrical or mechanical abnormalities (e.g. by resistance differences due to unbalances in the winding, commutator deformations etc.). The current transfer at this bar is disturbed, the electrically parallel brushes of the same polarity have to transfer more current and are thereby overloaded.

Advanced burn marks in pole-pitch also appear in an out-of-roundness measurement.

Remedial actions in case of commutation problems are:

- Check and if applicable adjustment of the neutral zone
- Check and if applicable adjustment of the interpole (interpole air gap)
- Check of the control device
- Check of the brush grade and
- Check of the brush design

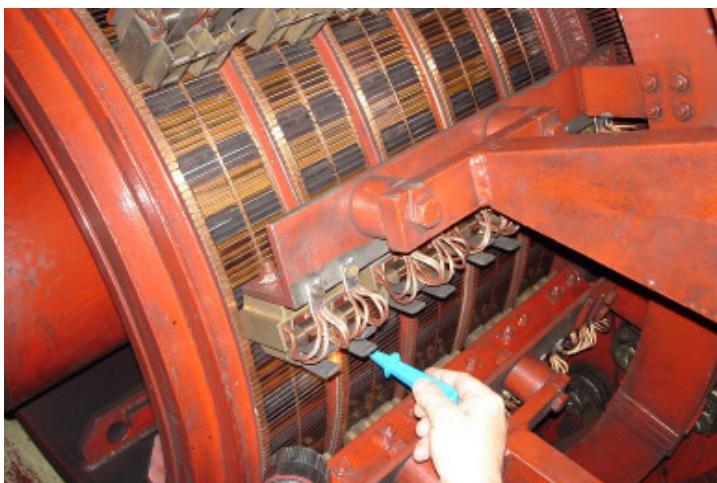
Broken commutator lead

Loosen or high resistance connections between the armature winding and the commutator bars cause burn marks, starting at the bar directly adjacent to the segment with the broken lead. The contact between brush and commutator gets worse and the whole commutator shows more and more sign of burning. In an advanced state flat spots and burn marks will show up, regularly distributed around the commutator perimeter.

Single bars with poor film formation due to reduced current flow are an indicator for broken commutator leads.

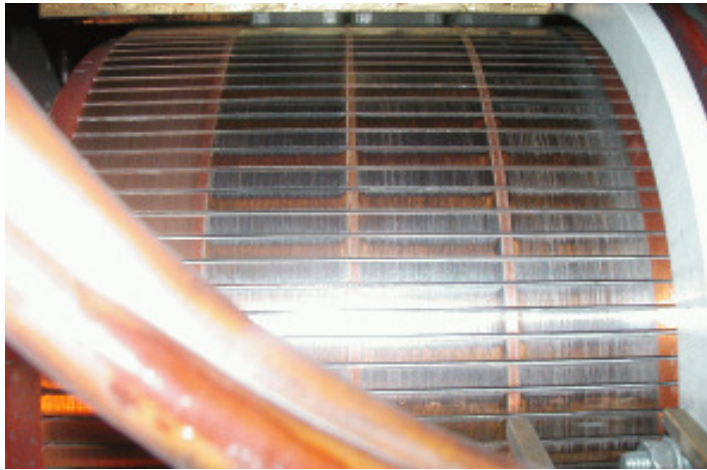
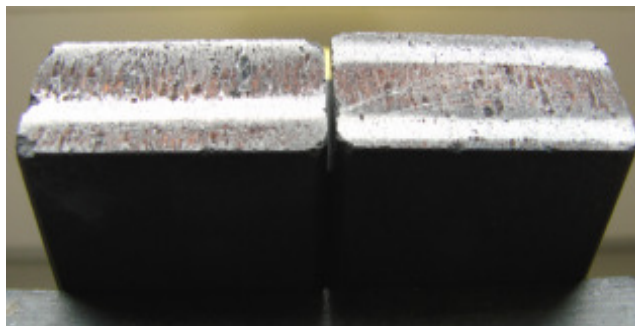
A by-product of bad commutation conditions is a special marking on the brush contact surface. The contact surface is divided in zones, each one bar width wide.

That phenomenon is caused by abnormally high current density in parts of the contact surface during dedicated phases of the commutating process.

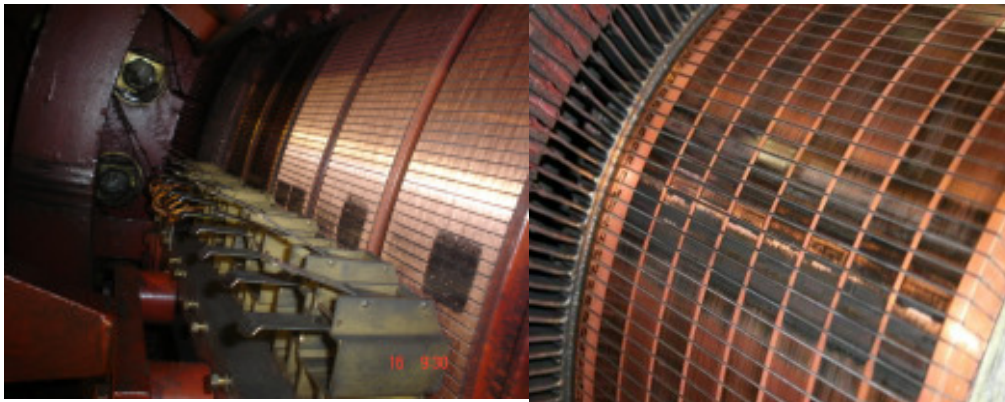
4. Standstill load

Due to the locally high temperatures in case of impermissible standstill load the copper of the commutator bar will be softened and changes its structure permanently. Thus flat spots and out-of-roundness will show up during operation.

The commutator bars will expand. Due to the arch pressure inside the commutator they will not move back to their original position while cooling down. That also causes out-of-roundness, brush vibration and further after-effects.

During standstill phases DC motors may be loaded only for a limited time to avoid damage of the commutator. At interval operation DC motor OEMs recommend a duration of max. 20 seconds at 100% overload.

It has to be considered, that standstill load in the same position of the rotor e.g. in case of restarts of blocked extruders etc. , may be repeated only, if commutator and armature are sufficiently cooled down.
